# Manhole Inspection Summary

Manhole # S25U\_\_001MH

Insp Date: **7/6/09 12:10 PM**

**Location** Address: **1621 Wicomico St.**

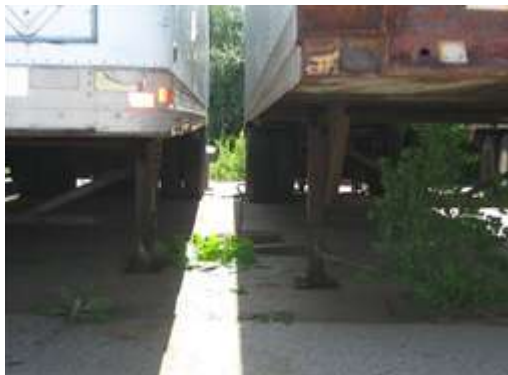
Location View

Southeastward view

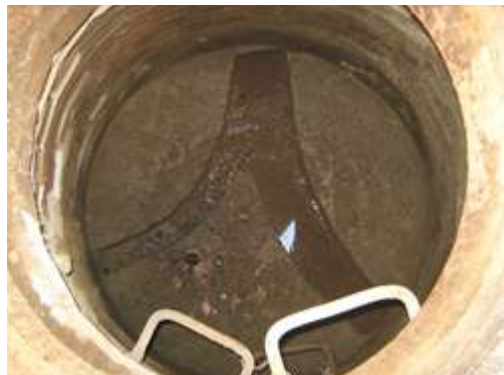
Top View

water service or bleeder

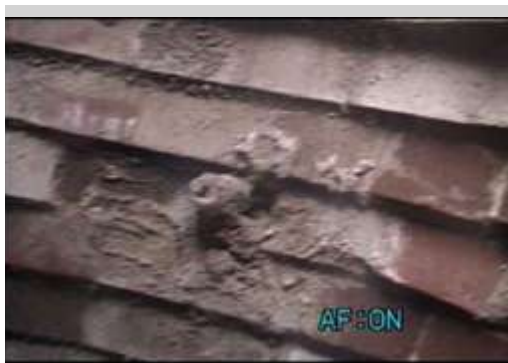
mud depoists around it

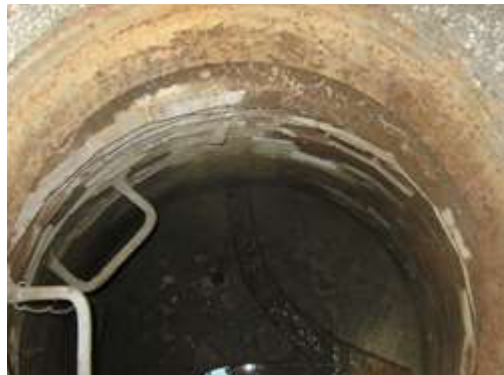
9 o clock

infiltration visible from frame to barrel

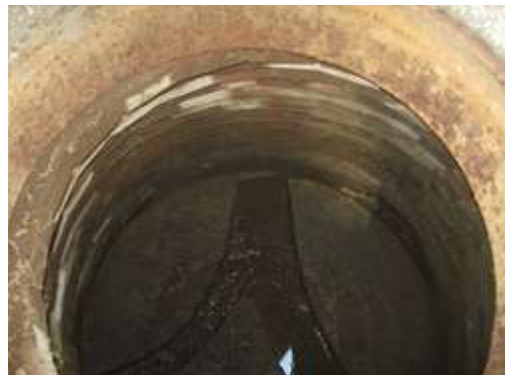
12 o clock

corbel and barrel infiltration

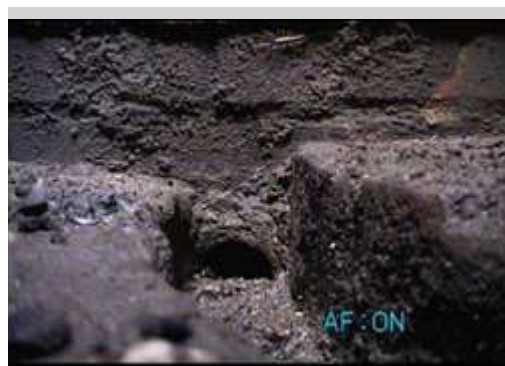
Defect 3

Condition: ☐ Sound ☐ Cracked ☐ Root Intrusion ☐ Deteriorated ☐ Leaks ☒ Debris

channel debris

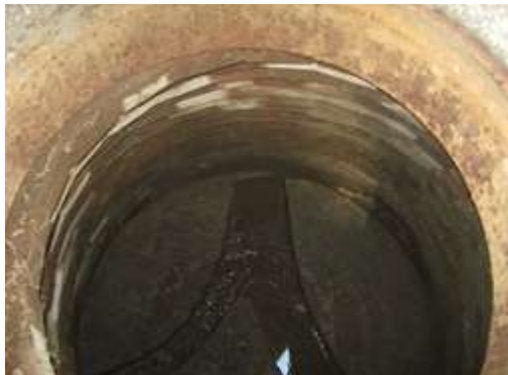
Defect 2

Infiltration: ☐ None ☐ Joint ☐ Cracks ☒ Mortar ☐ Roots ☒ Wall

Infiltration: ☐ None ☐ Joint ☐ Cracks ☒ Mortar ☐ Roots ☐ Wall

corbel and barrel infiltration

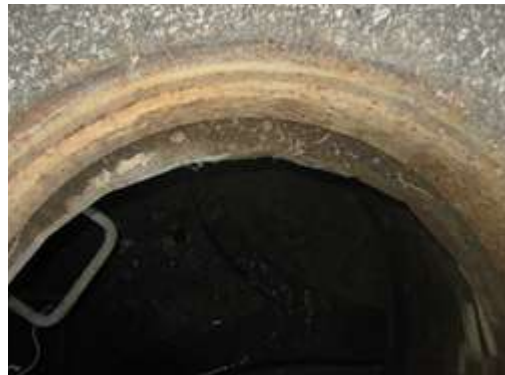
Defect 1

Offset: **1.5** (in.)

frame offset

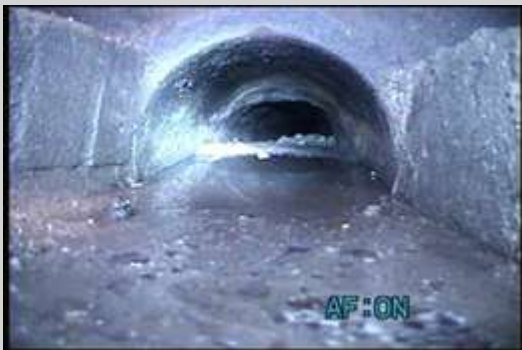
12 O'Clock Outflow

6 in. Circular Gravity Sewer  
Pipe Out @ 12 O'Clock

Pipe Height: **4.8** (in.) Rod and Bar (Angled)  
Pipe Material: **Clay** ☐ Pipe Lined  
Invert Depth: **5.30** (ft.) Flow Characteristics: **None**  
Deposits: ☒ None ☐ Mud ☐ Sludge ☐ Debris ☐ Grease  
Silt Depth: **0** (in.) Deposits Extent:  
Infiltration: **None** Pipe Seal Cond: **Sound**

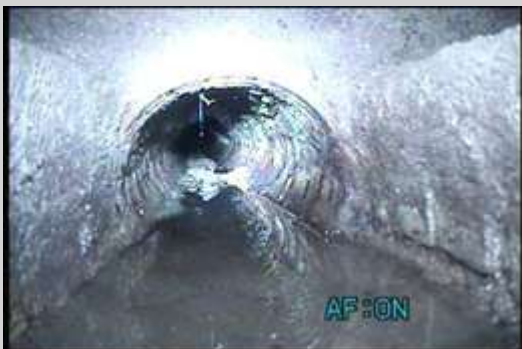
5 O'Clock Inflow

4 in. Circular Gravity Sewer  
Pipe In @ 5 O'Clock

Pipe Height: **6** (in.) Rod and Bar (Angled)  
Pipe Material: **Clay** ☐ Pipe Lined  
Invert Depth: **5.24** (ft.) Flow Characteristics: **None**  
Deposits: ☒ None ☐ Mud ☐ Sludge ☐ Debris ☐ Grease  
Silt Depth: **0** (in.) Deposits Extent:  
Infiltration: **None** Pipe Seal Cond: **Sound**

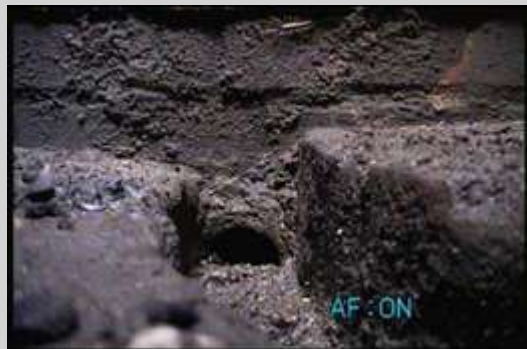
8 O'Clock Inflow

4 in. Circular Gravity Sewer  
Pipe In @ 8 O'Clock

Pipe Height: **3.6** (in.) Direct (Angled)
